ANNUAL REPORT FOR 2010

Middle Fork Creek Site E Mitigation Site
Madison County
TIP No. R-2518A

Prepared By:
Natural Environment Unit & Roadside Environmental Unit
North Carolina Department of Transportation
December 2010

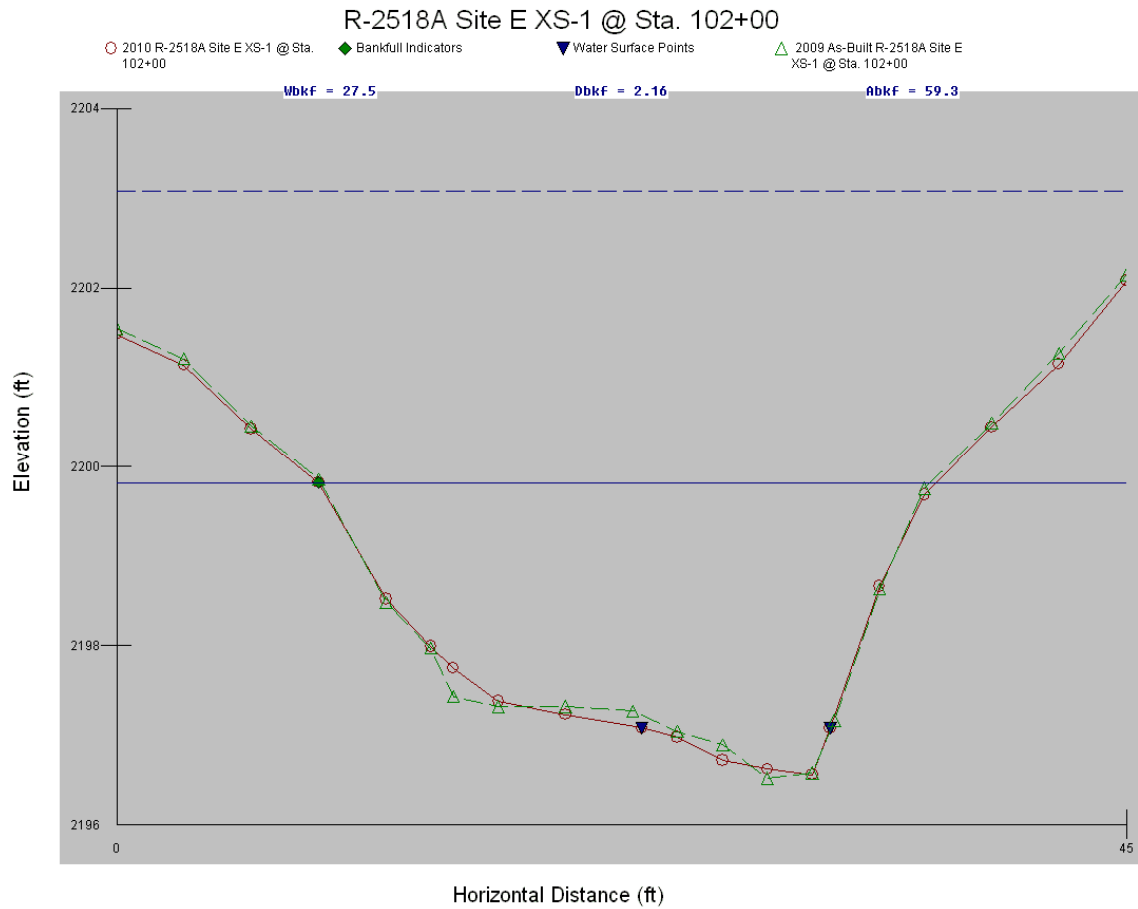
Site E: Cross-Section #1 (Riffle) Abbreviated Morphological Summary					
	2010	2011	2012	2013	2014
Bankfull Cross Sectional Area (ft ²)	59.32				
Maximum Bankfull Depth (ft)	3.26				
Width of the Floodprone Area (ft)	45				
Bankfull Mean Depth (ft)	2.16				
Width/Depth Ratio	12.74				
Entrenchment Ratio	1.64				
Bankfull Width (ft)	27.51

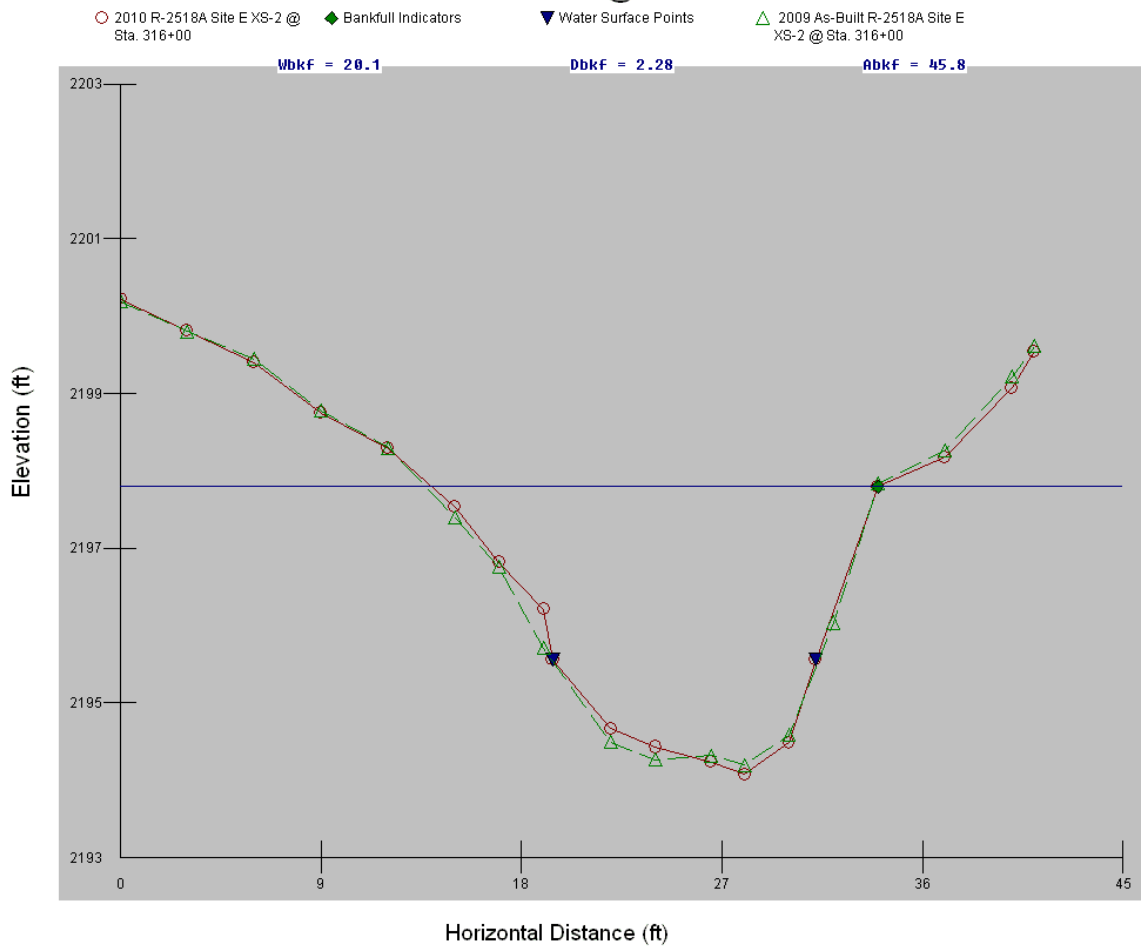
R-2518A Site E XS-2 @ Sta. 316+00

Site E: Cross-Section #2 (Pool) Abbreviated Morphological Summary					
	2010	2011	2012	2013	2014
Bankfull Cross Sectional Area (ft ²)	45.83				
Maximum Bankfull Depth (ft)	3.72				
Bankfull Mean Depth (ft)	2.28				
Bankfull Width (ft)	20.07

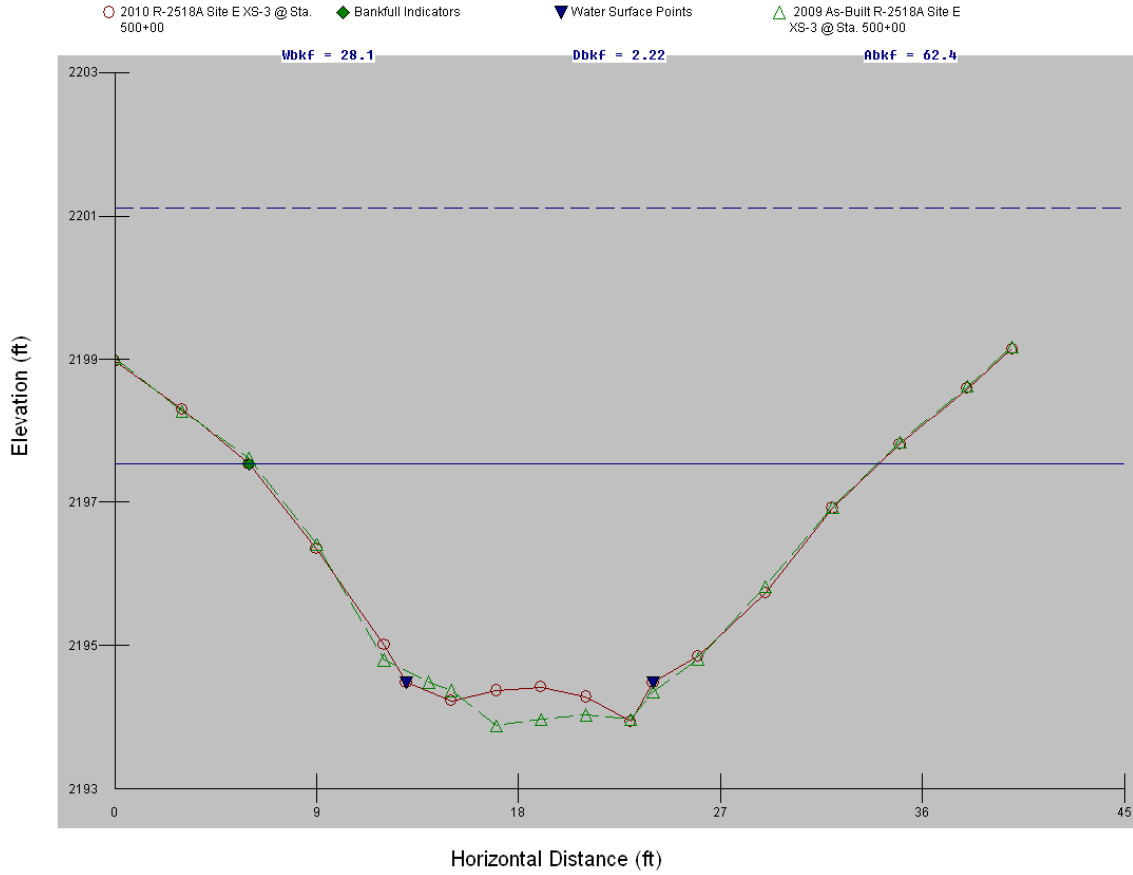
R-2518A Site E XS-3 @ Sta. 500+00

Site E: Cross-Section #3 (Riffle) Abbreviated Morphological Summary					
	2010	2011	2012	2013	2014
Bankfull Cross Sectional Area (ft ²)	62.4				
Maximum Bankfull Depth (ft)	3.59				
Width of the Floodprone Area (ft)	40				
Bankfull Mean Depth (ft)	2.22				
Width/Depth Ratio	12.64				
Entrenchment Ratio	1.43				
Bankfull Width (ft)	28.06

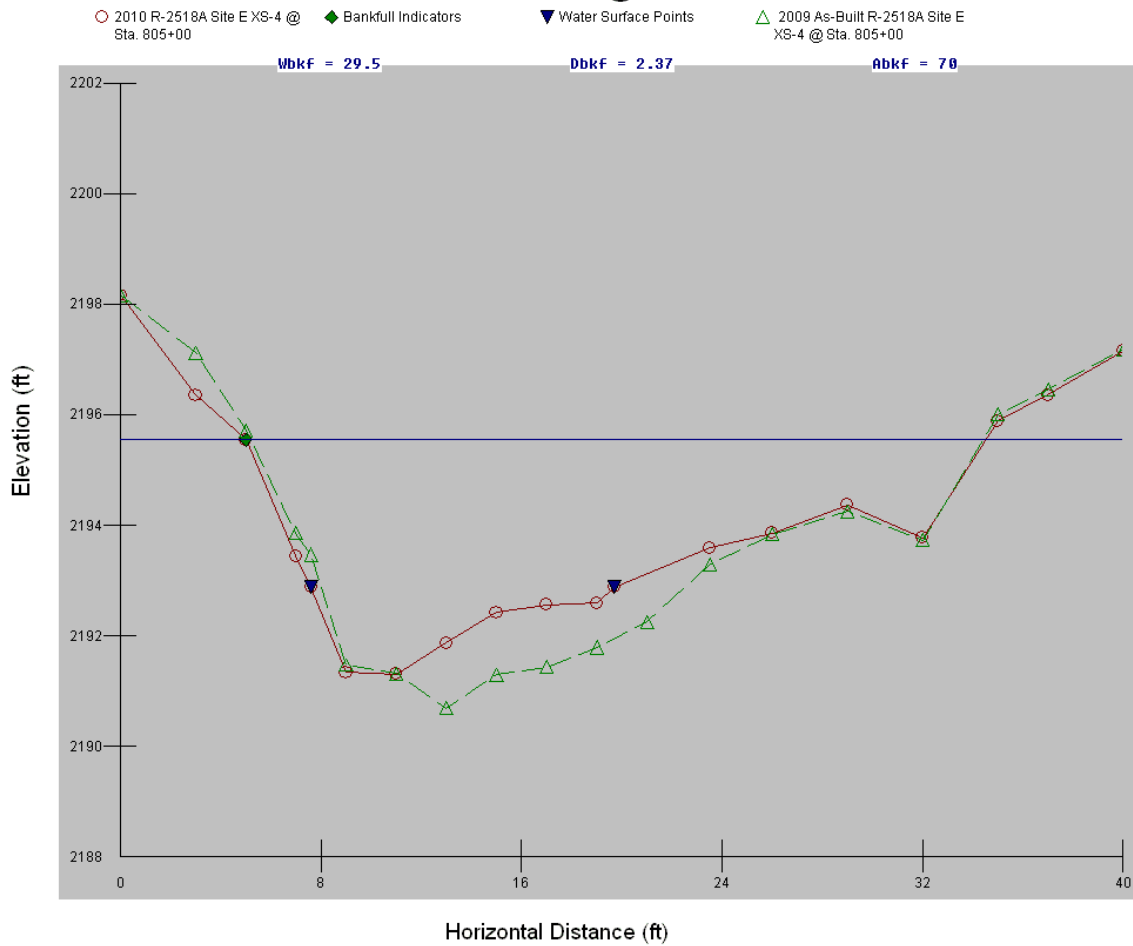
R-2518A Site E XS-4 @ Sta. 805+00

Site E: Cross-Section #4 (Pool) Abbreviated Morphological Summary					
	2010	2011	2012	2013	2014
Bankfull Cross Sectional Area (ft ²)	69.95				
Maximum Bankfull Depth (ft)	4.24				
Bankfull Mean Depth (ft)	2.37				
Bankfull Width (ft)	29.53

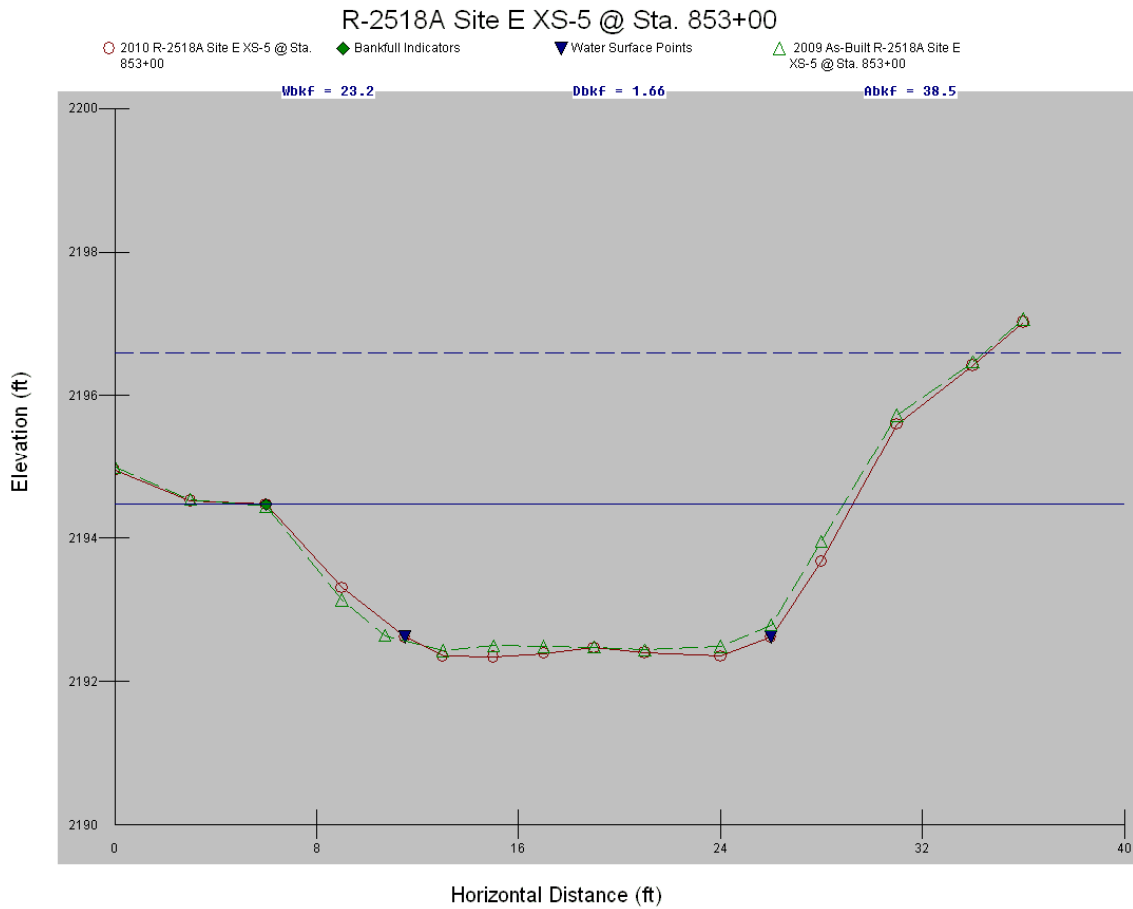
Site E: Cross-Section #5 (Riffle) Abbreviated Morphological Summary					
	2010	2011	2012	2013	2014
Bankfull Cross Sectional Area (ft ²)	38.49				
Maximum Bankfull Depth (ft)	2.13				
Width of the Floodprone Area (ft)	34.6				
Bankfull Mean Depth (ft)	1.66				
Width/Depth Ratio	14				
Entrenchment Ratio	1.49				
Bankfull Width (ft)	23.24
